**FIVE-YEAR REVIEW
FINAL REPORT**

**POWERSVILLE LANDFILL SITE
POWERSVILLE, PEACH COUNTY, GEORGIA**

DECEMBER 1997

**Roy F. Weston, Inc.
5405 Metric Place, Suite 200
Norcross, Georgia 30092**

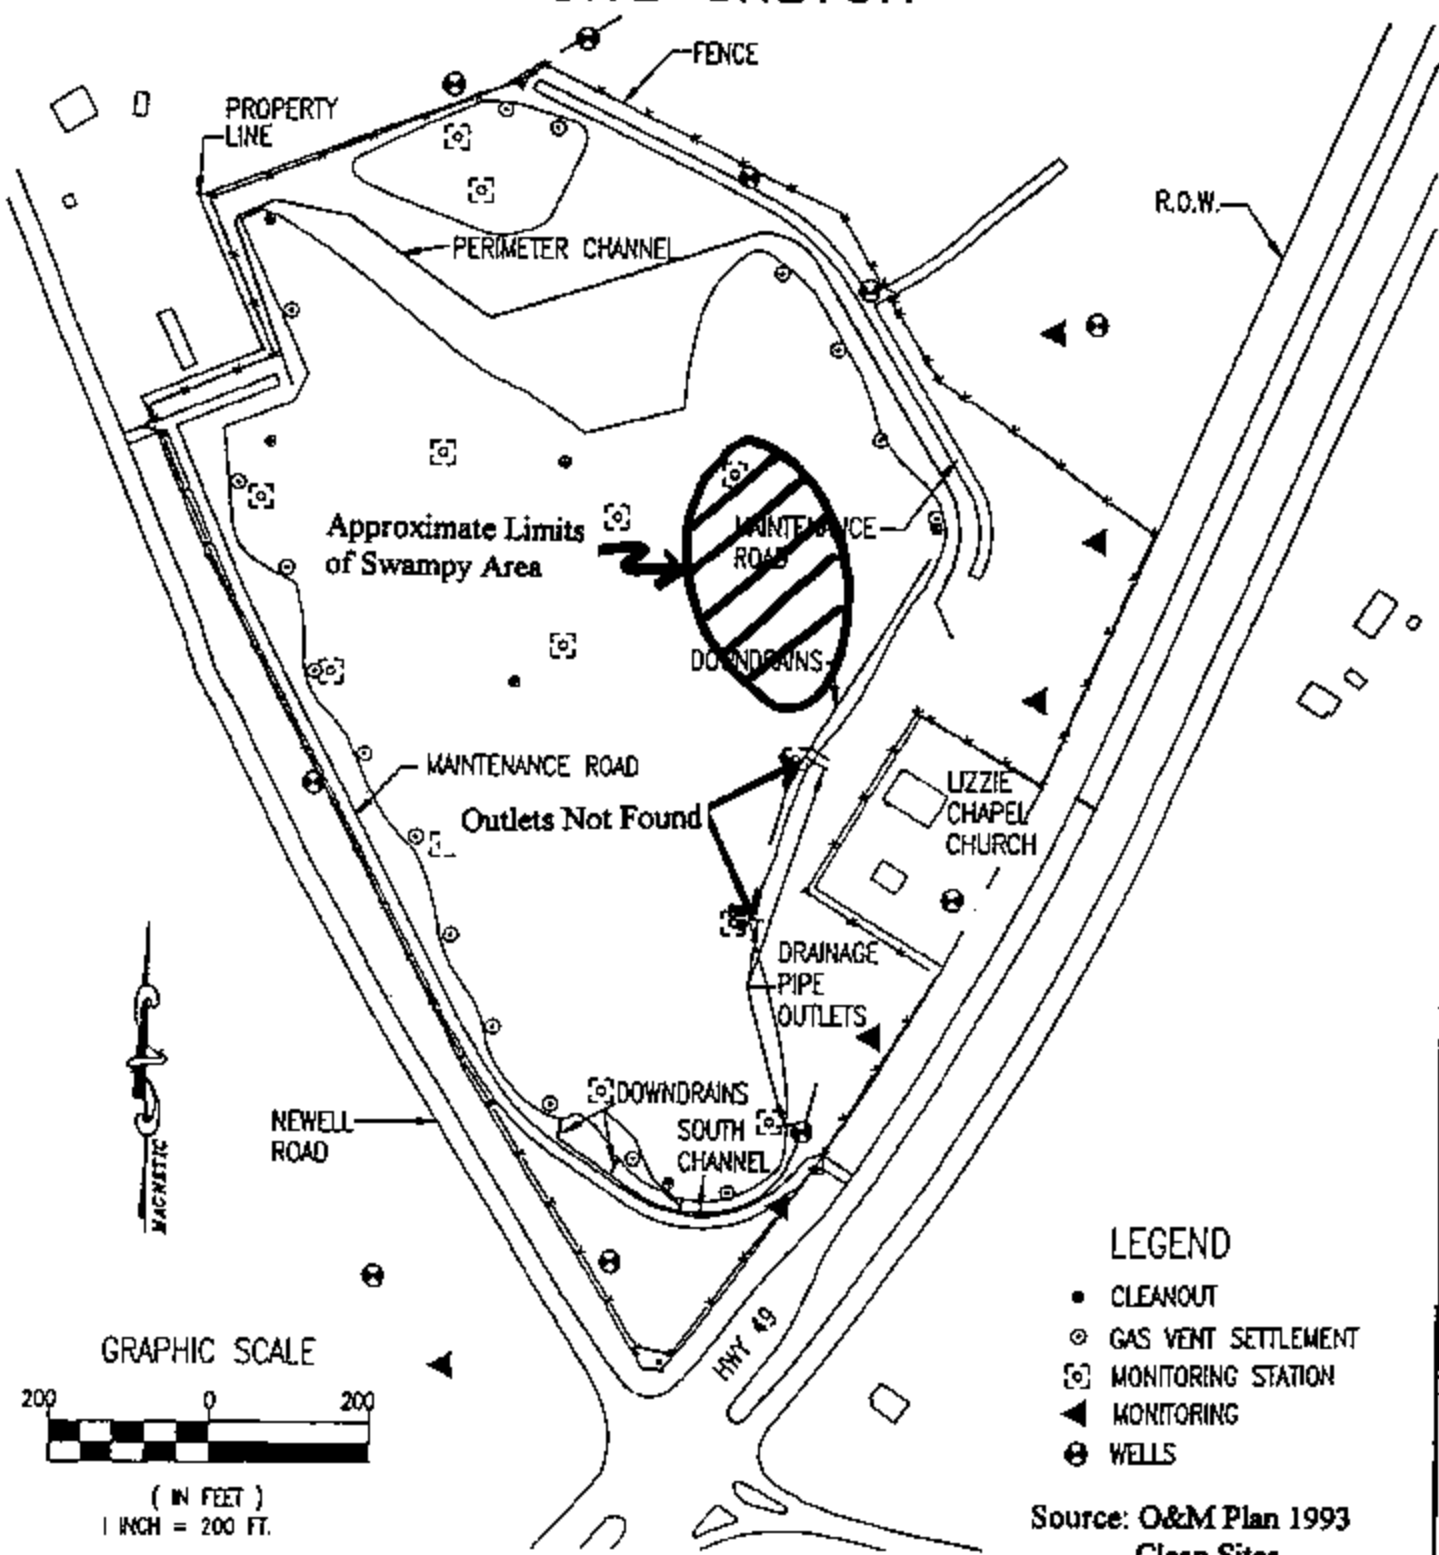
SITE SKETCH

2-1, three of these are supposed to exist along the south and east sides of the landfill. Only one of these was found by WESTON. The other two are apparently covered or have settled into the cover soil. The function of these outlets are to provide a positive outlet from the cover drainage layer. WESTON observed a swampy area shown on Figure 2-1, which is in a relatively flat portion of the landfill. This could be a result of settlement and/or plugging of the remaining two pipe outlets in the vicinity. The negative effects of this swampy or ponded area is documented in Section 4.2.1 (Page 4-14) of the Operations and Maintenance Plan, August 19, 1993, as follows:

A swampy condition on the relatively flat portion of the cover exists on the east side. This could be caused by non-functioning drainage layer pipe outlets.

The drainage layer pipe outlets should be investigated to determine the location and potential link to the swampy area as shown on Figure 2-1. If the outlets are plugged due to settlement, repairs should be performed in accordance with Section 15.6.3 of the Operation and Maintenance Manual, August 19, 1993, prepared by CSES.

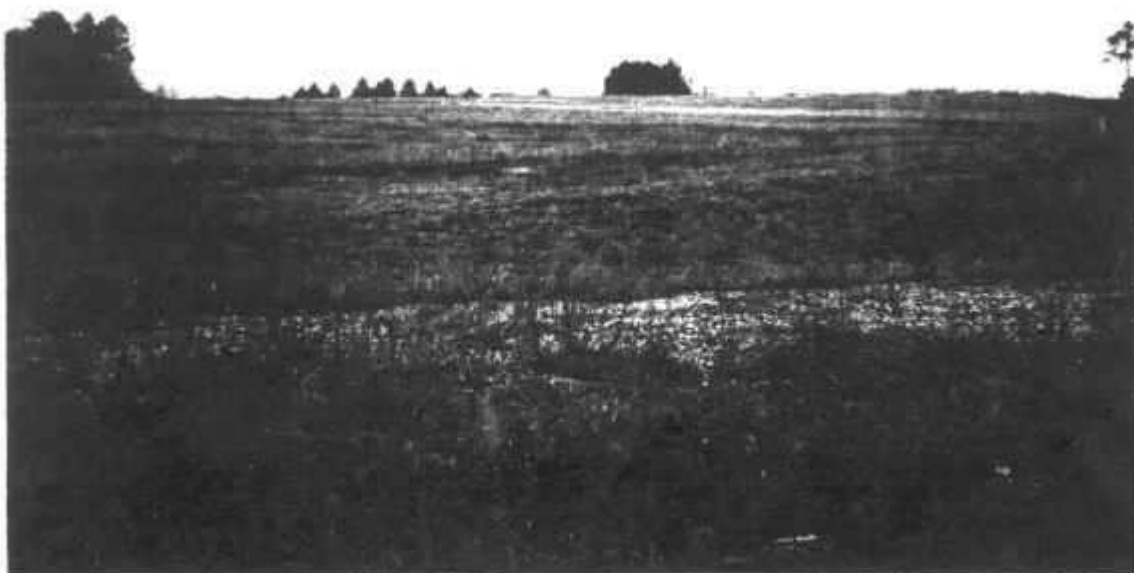
Photograph No. 2

Looking over the entire site from the entrance gate (Photograph No. 2), the cover system appears to be well maintained. Walking along the perimeter just inside the fence line, some unvegetated

Description: View of the Site as standing at the entrance gate looking northwest.

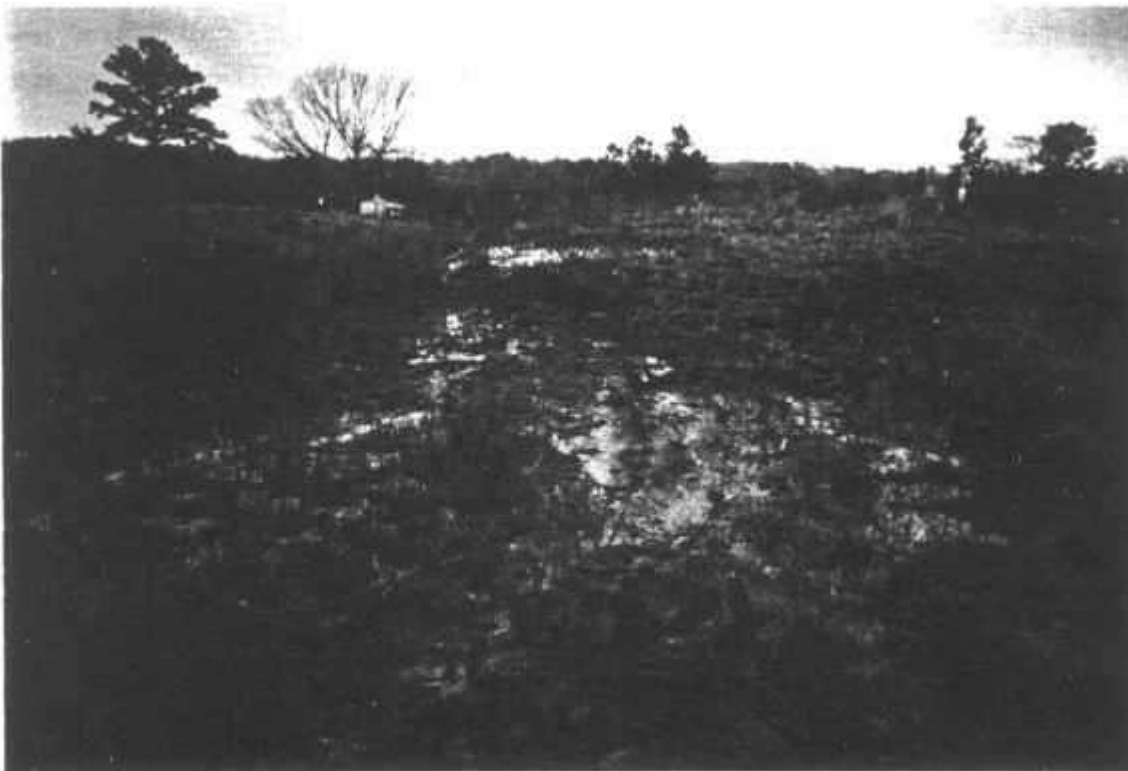
Photograph No. 3

areas with minor erosion was observed (Photograph No. 3). This can only be corrected by reseeding the bare areas to establish a continuous vegetative cover.

Description: Lack of vegetation and signs of minor erosion observed along the east side of the landfill.

The small bare soil areas require reseeding to establish permanent vegetation for erosion protection on the cover system. Consultation with the local National Resource Conservation Service of the U.S. Department of Agriculture is recommended to obtain the proper application rates and fertilization requirements best suited for the local conditions.

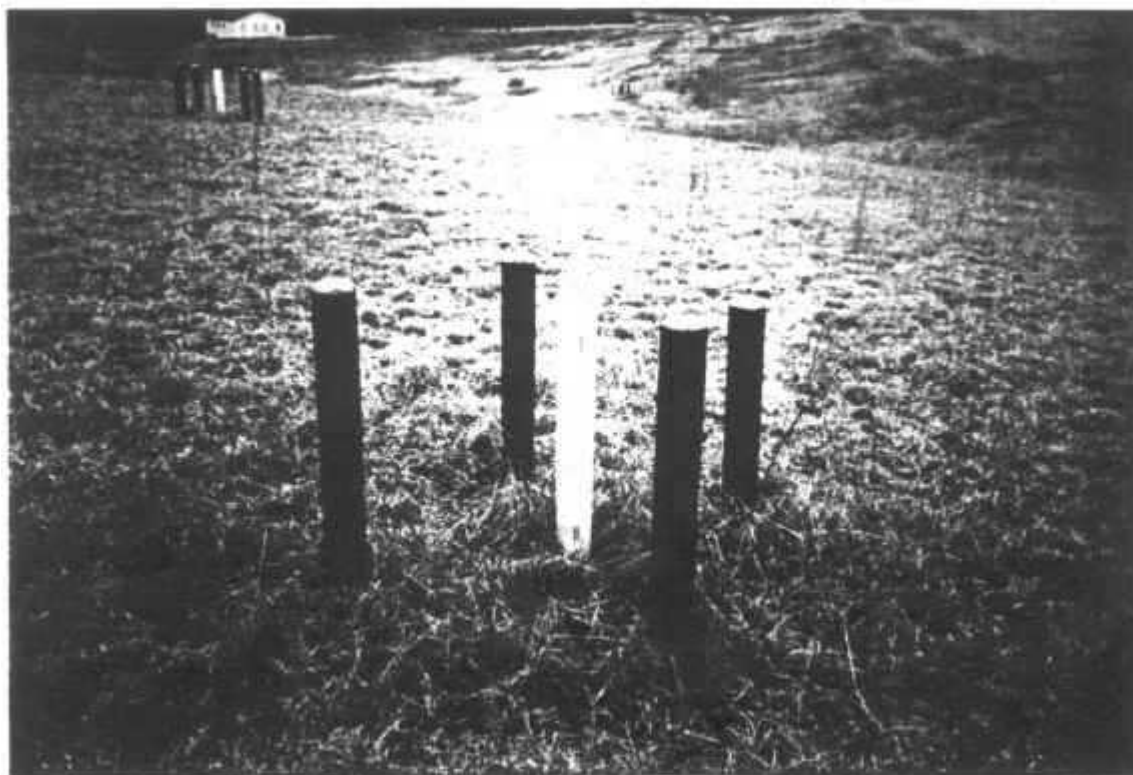
WESTON's McKeen continued the site reconnaissance and observed the monitoring features of the landfill. Photograph No. 4 shows one of the settlement monitoring stations protected by guard posts. All of the stations were in good shape with the brass disk for surveying still in place.

Description: A settlement station post (white) which is protected by 4 steel guard posts.

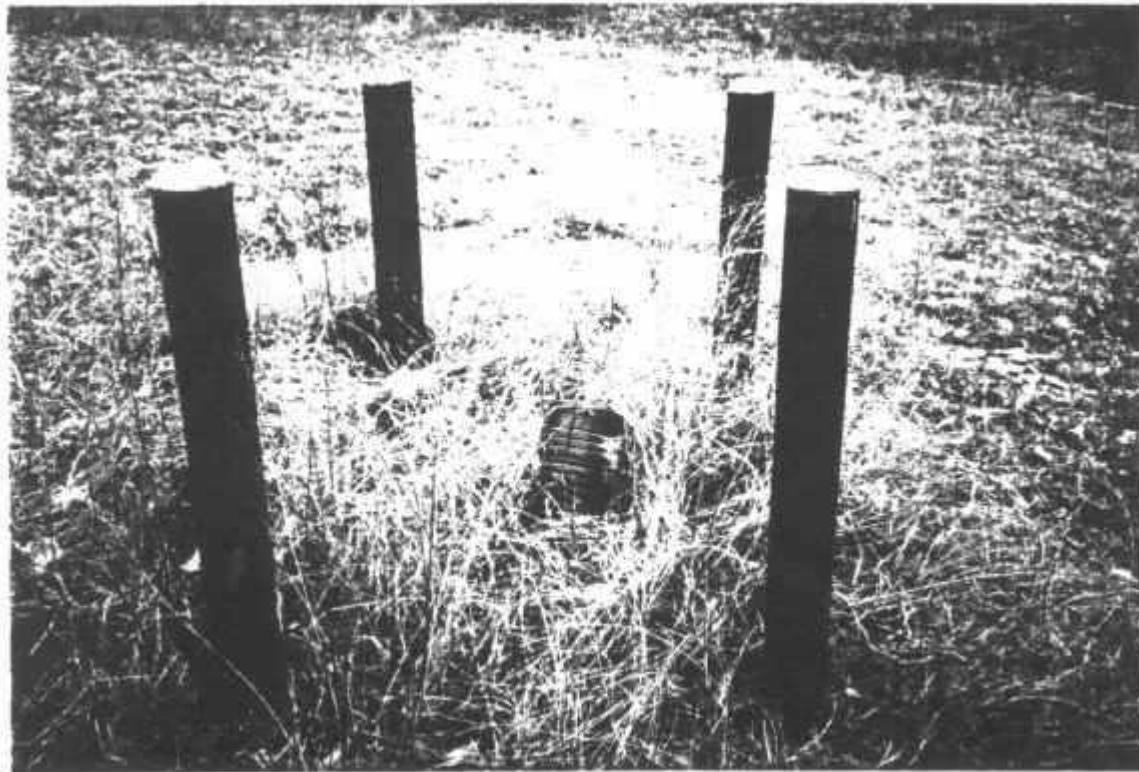
Photograph No. 5

The next two monitoring features observed were the cover drainage pipe cleanout (Photograph No. 5) and the passive gas vents (Photograph No. 7). Again, all of these structures appeared to be in good condition with adequate guard posts for protection.

Description: Cover drainage pipe cleanout made of corrugated HDPE pipe and protected by 4 steel guard posts.

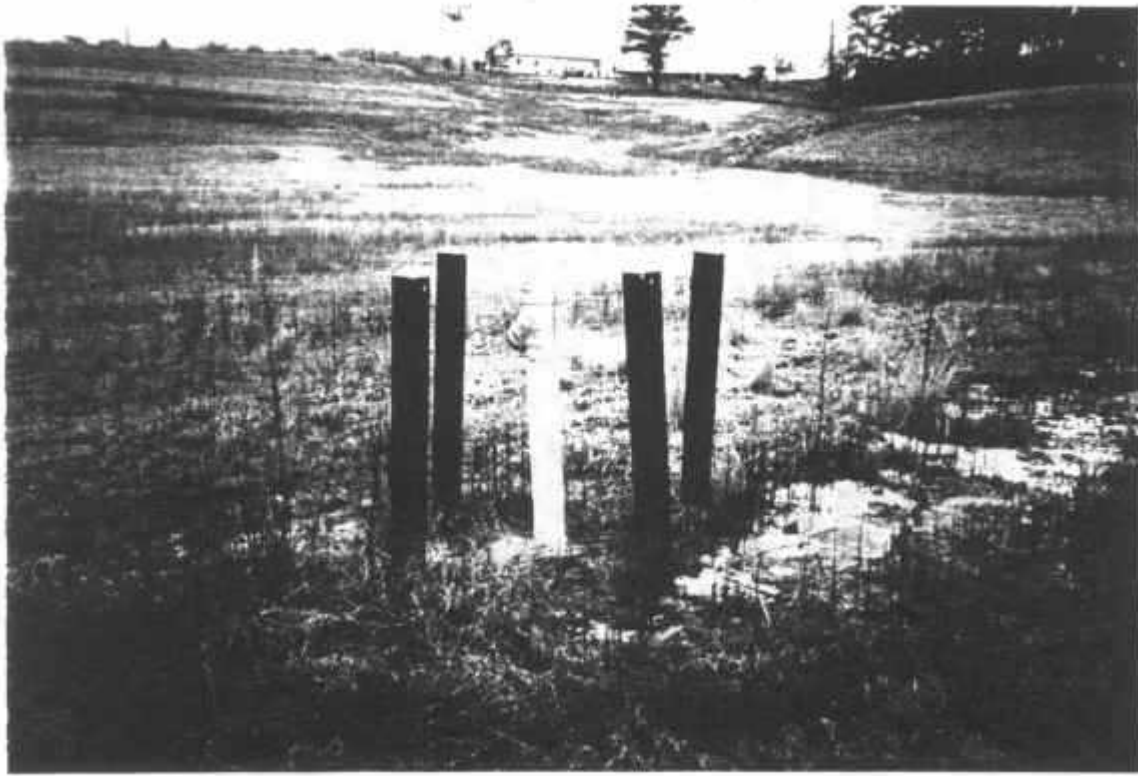
Photograph No. 7

Description: Gas vent (white with yellow cap) near the center of the landfill. Vent has nylon screen over opening and is protected by 4 steel guard posts.

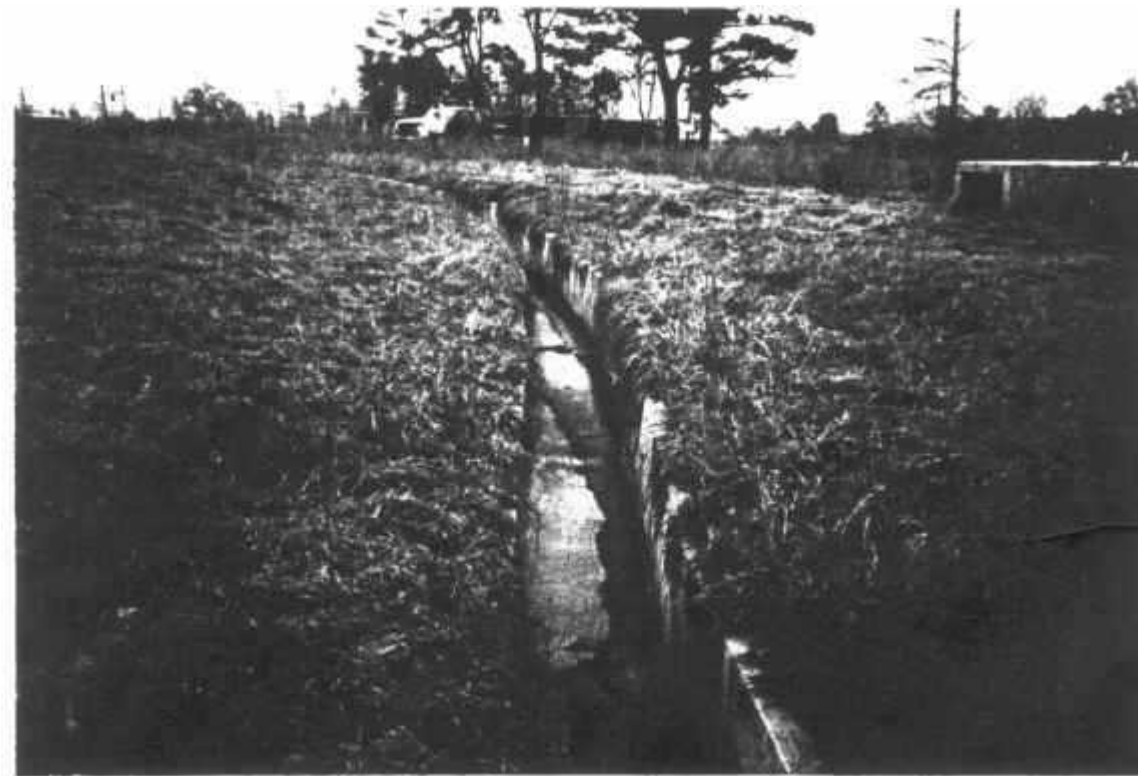
Photograph No. 8

The concrete stormwater drainage channels (Photographs No. 8 and No. 9) are clean and of good structural integrity. These channels provide stormwater conveyance to the detention ponds at the south end of the site. Also noted was the perimeter fence which is constructed of chain link with three strands of barbed wire on top (Photograph No. 9). This fence is in good shape and has warning signs posted approximately every 100 feet.

Description: View of concrete surface water drainage channel leading to one of the two stormwater detention ponds.

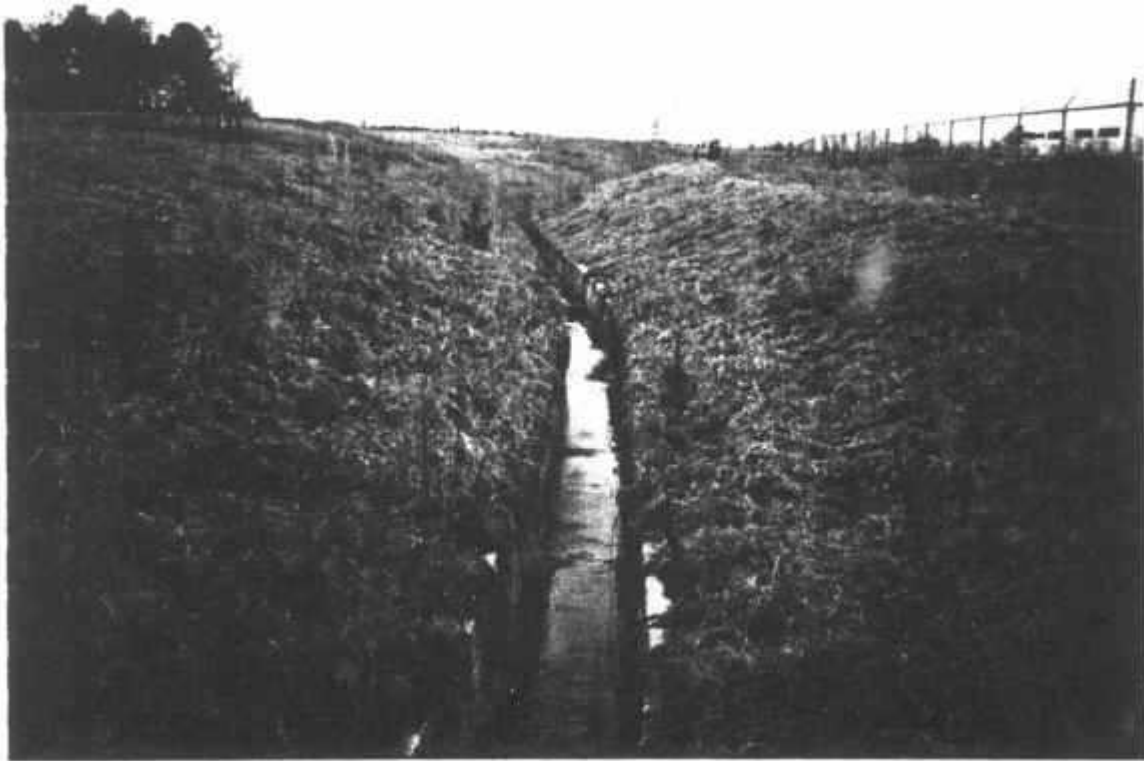
Photograph No. 9

Description: Concrete drainage channel along east side of the site. Chain link fence with 3 strands of barbed wire completely surrounds the site.

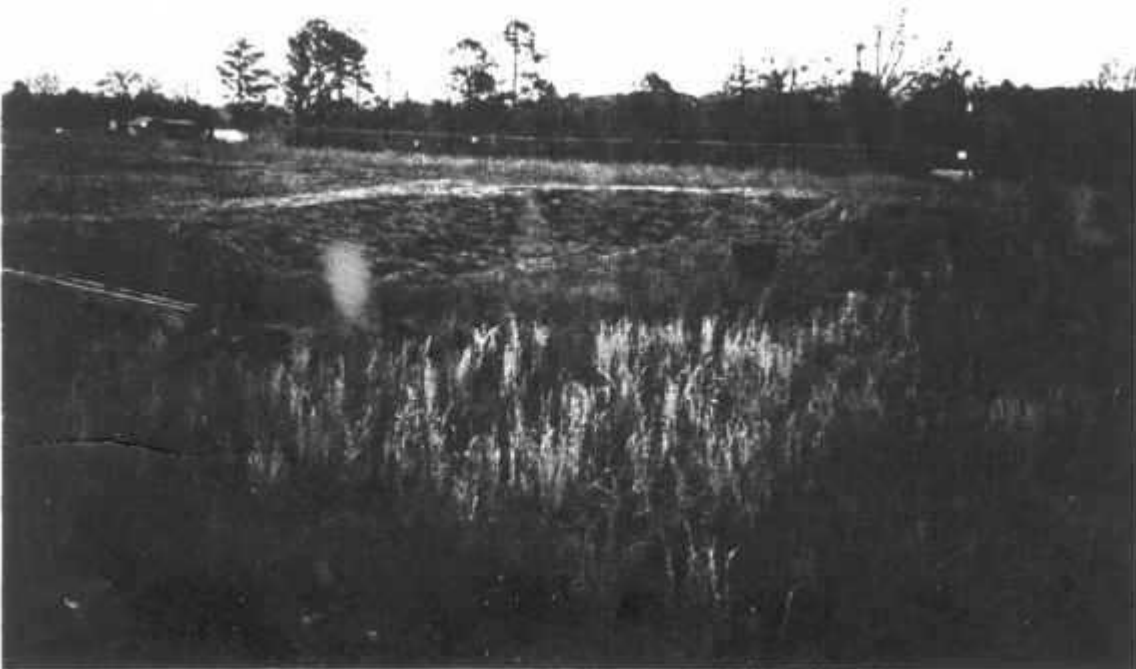
Photograph No. 10

Both stormwater detention ponds appear to be in good condition. Since the site is well vegetated, minimal sediments should accumulate. The ponds will, however, provide for attenuation of peak flows during storm events so that the receiving ditches along Highway 46 are not flooded.

Description: The southeast stormwater detention pond. The spillway outlet from the pond drains to the ditch along Highway 49.

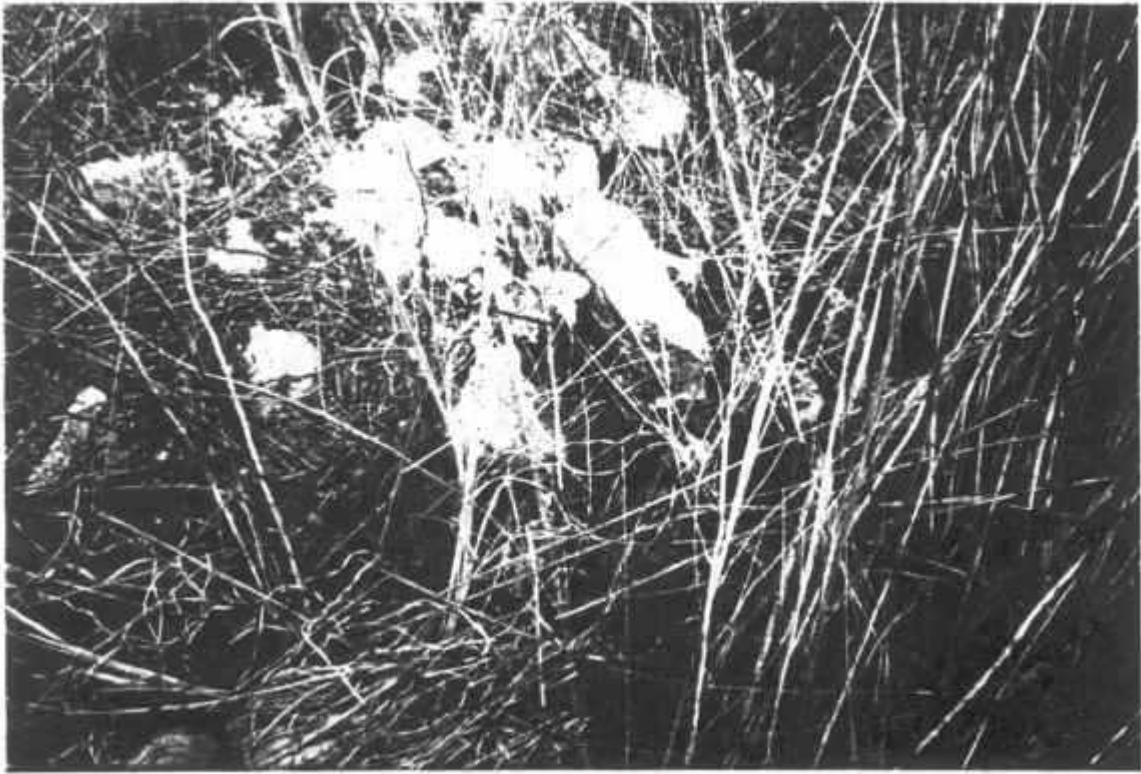
Photograph No. 13

The last feature of the landfill observed during the site reconnaissance was the subsurface drainage pipe outlets (Photograph No. 13). According to the O&M Plan and, as shown on Figure
